**DEPARTMENT OF TRANSPORTATION**

Contract #: 04-0120F4Cty: SF/ALA Rte: 80 PM: 13.2/13.9File #: 69.28**WELDING INSPECTION REPORT****Resident Engineer:**Siegenthaler, Peter**Address:** 333 Burma Road**City:** Oakland, CA 94607**Report No:** WIR-025175**Date Inspected:** 02-Jul-2011**Project Name:** SAS Superstructure**OSM Arrival Time:** 1900**Prime Contractor:** American Bridge/Fluor Enterprises, a JV**OSM Departure Time:** 700**Contractor:** Zhenhua Port Machinery Company, Ltd (ZPMC), Changxing Island **Location:** Shanghai, China

### Segment 14West initial blast Inspections, Blast Bay 4

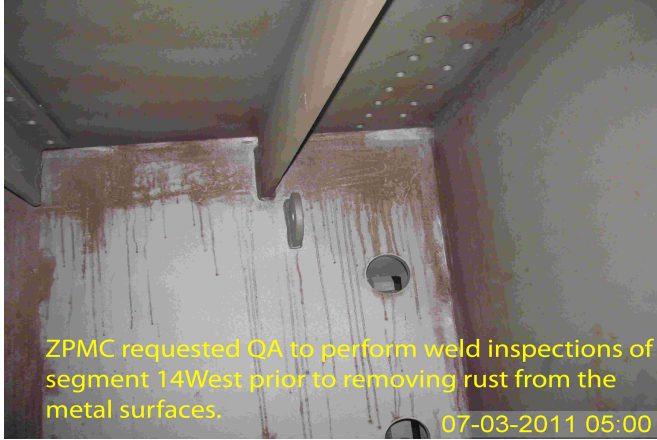
ABF verbally requested Caltrans personnel to perform visual inspections of OBG segment 14W anchor plate, adjacent ceiling and vertical plates from between the anchor plate and the end of the segment. This QA Inspector and two other QA Inspectors performed initial visual inspections of these areas and observed many of the welds and adjacent base material surfaces had a coating of rust and the areas do not appear to have been initially blasted. This rust prohibits adequate visual inspections of these areas and QA Inspectors did not perform visual inspections of these areas. This QA Inspector informed ABF Paint Inspector "Stone" that the areas were not ready for inspections and he said he was not involved in this inspection but he would pass on the information to other ABF and ZPMC personnel. Photos of some of these areas were placed on the common "Z" drive under 14W Blast Inspections. See the photograph below for additional information.
